## **REPORT NO. 02-15**

# NAILED FLOOR-LINE BLOCKING METHODS TP-94-01, "TRANSPORTABILITY TESTING PROCEDURES"

VALIDATION ENGINEERING DIVISION MCALESTER, OKLAHOMA 74501-9053

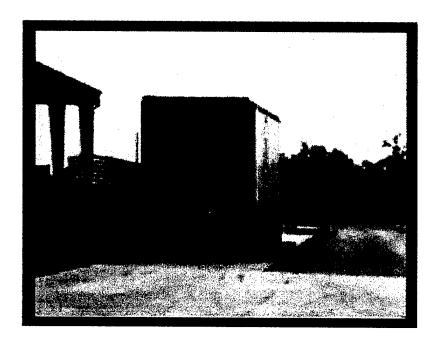
Photo 3. 155MM SLP over Hazard Course

- 1. Figure 2 lists the average speed of the test load through the Hazard Course.
- 2. The front header at the door end passenger side moved 2 inches toward the door of the trailer. This permitted the 155MM SLP to move excessively.
- 3. The side blocking located in the closed end of the trailer on the passenger side pulled loose from the floor. This allowed the 155MM SLP to slide against the trailer wall.
- 4. Due to the excessive load movement the testing was stopped.

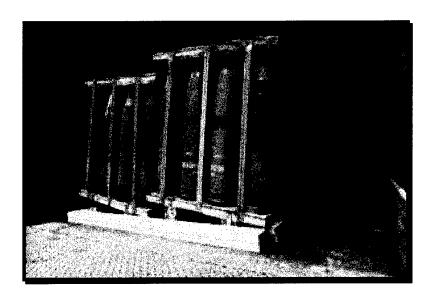
Photo 5. Movement of the Payload at the Door End of the Trailer

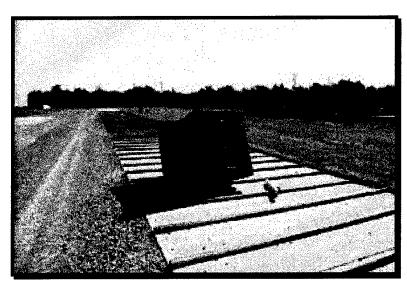
- 1. Figure 6 lists the average speeds of the test load through the Hazard Course.
- 2. Inspection following Pass #4 revealed that the load moved 0.5 inches toward the door of the trailer.
- 3. Inspection following Passes #3 and #4 revealed no excessive movement of the payload or damage to the trailer or blocking and bracing.
- 5. <u>WASHBOARD COURSE</u>. The washboard test was conducted for informational purposes only. The rear header (door end) separated from the trailer floor. This allowed the entire load to move toward the trailer door. One pallet of the PA116 Containers fell from the trailer.

Photo 15. PA116 Container Pallet After Dropping From the Trailer During Washboard Course

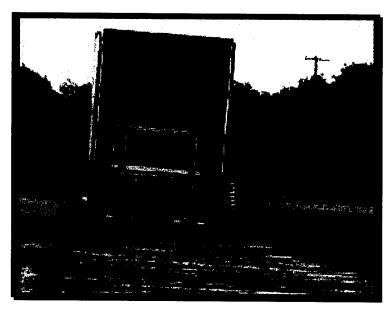
Photo 23. Washboard Course Testing of the 155MM SLP Payload

- 1. The washboard test was conducted for informational purposes only.
- 2. The load-bearing gate, at the trailer door was damaged. During transport over the hazard course the passenger side bay of 155MM SLPs bounced onto the end blocking. The load moved toward the door of the trailer and damaged the gate.
- 3. The end blocking separated from the floor 0.3 inches at the door end of the trailer.
- 4. The end blocking (closed end) of the second bay of 155MM SLPs moved forward 0.25 inches due to the nails bending.
- 5. The load bearing gate (door end) fill piece of the second bay of 155MM SLPs disengaged.

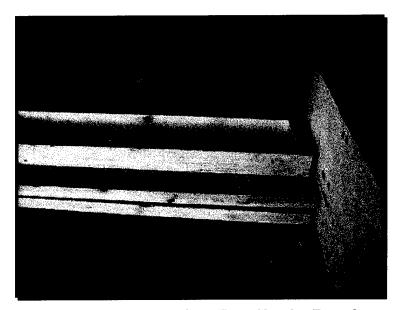
- 1. The washboard test was conducted for informational purposes only.
- 2. Inspection following completion of the washboard course revealed that the top of the rear header at the door end on the passenger side had separated an additional 0.38 inches from the board below. Total separation was now 1.0 inch.
- 3. Inspection following completion of the washboard course revealed no excessive movement of the payload, damage to the trailer or the blocking and bracing.

Photo 29. Separation of the Rear Header Board

**B.** <u>CONCLUSION:</u> The nail pattern successfully completed the required testing. However, during testing the top board of the rear header at the door end passenger side did separate a total of 1 inch from the header bottom.
